magicolor 24x0 / 25x0 series

Fatal error code 18H/19H/24H/1AH/1BH Update!!!

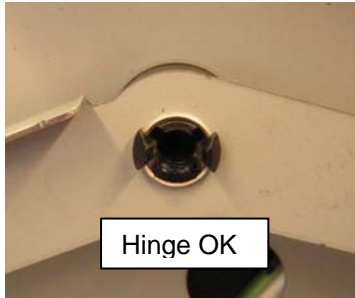
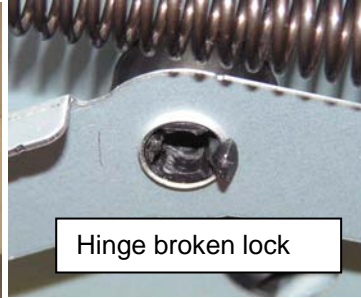
Beside for checking/repairing the fusing safety switch it also might happen that the arm does not work properly, make sure it is not very loose on the hinge and check if the 2 locking pins are not broken off.

If the hinge is ok but the arm is loose please use a self tapping screw (5 mm) to lock the arm on the hinge.

If there is a locking pin broken of from the hinge please use a self tapping screw (5mm) and a washer (14mm) to lock the arm on the hinge.

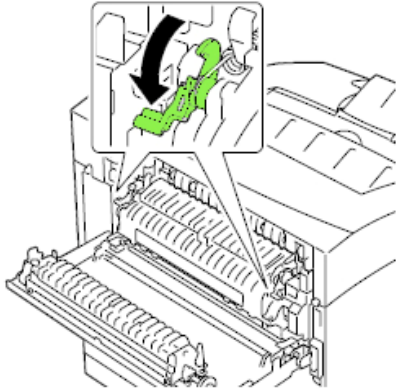
Incorrect fusing / smudges / stripes / Ghosting / dirt on the back side of the paper / paper jams in the fusing section.

This could be the result of the fuser not being locked correctly, so please check that the lock levers (green levers) are in the correct position (downwards).
